FIRE IN U.S. ARMY HELICOPTER ACCIDENTS

1 JULY 1957 THROUGH 30 JUNE 1965

By
Emil Spezia

Report No. HF 67-1

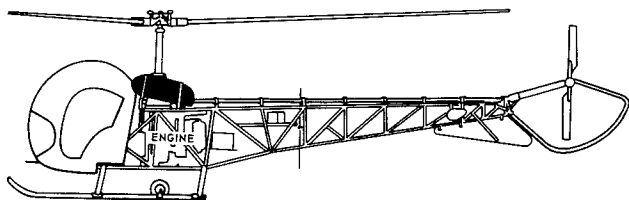
FIGURE 2

During the eight years this report covers, the fuel system of the OH-13G and H demonstrated the least resistance to failure during crashes. This observation helicopter, which has been one of the mainstays of Army operations, accounted for 38% of the survivable post-crash fire accidents. Its main design deficiency is the unprotected location of its twin fuel tanks (see Figure 2).

OH-13 Models G and H Twin Fuel Cells

The survivable fire accident rate of the OH-13G and H over the years has been five times that of the D and E. In 91% (32 of 35) of the survivable fire accidents shown on Table 3, fire was due to a rupture or puncture of the fuel tanks or fuel lines. Added fuel capacity, needed for the D and E to grow into the higher performing G and H, required larger tanks. The change resulted in the design decision to install twin tanks with a combined capacity of 43 gallons. This new location was needed for the enlarged tanks because it would least affect the helicopter's center of gravity (see Figure 2). The enlarged twin tanks in this location, saddled on each side of the rotor mast above the engine, crowded the available protective space the airframe gave to the D and E tank. Because of their enlarged size, the twin tanks were moved nearer the rotor mast and

were often punctured by the swash plate when the mast became displaced during a crash. Larger dimensions also caused the tanks to extend beyond the protection of the airframe, which makes them among the first parts of the aircraft to strike the ground. In the event of roll-over, which is characteristic of a helicopter accident, the twin tank configuration always leaves one tank atop to leak fuel. This point is illustrated by the following excerpts of statements given in two accidents:

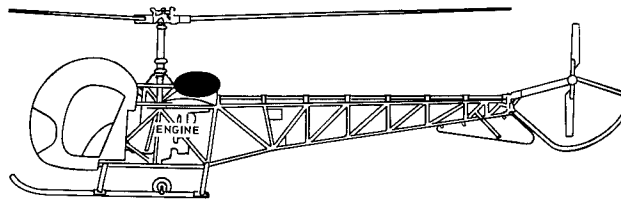
FIGURE 3

OH-13 Models D and E Single Fuel Cell

The reason for the OH-13D and E low rate, now that it can be compared with the G and H, is believed to be due to its single 29-gallon tank, mounted above the engine and aft of the rotor mast (see Figure 3). In this location, the tanks are relatively well protected from rupture and puncture damage. However, Table 3 shows that in five of its six fire accidents, either the tank or the adjoining fuel lines failed to prevent fuel spillage. This fact points out that this location is still not ideal, because, when fuel is spilled, it has quick access to the many ignition sources available about the engine.

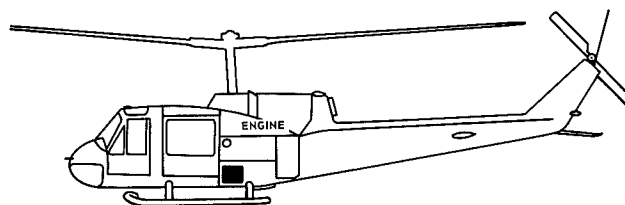
FIGURE 4

The earlier study gave an indication that because of the protective location of the UH-1A and B fuel cells (see Figure 4), these would be expected to

UH-1 Models A and B Bladder-Type Fuel Cells Aft of Cockpit

earn a low fire accident rate. The UH-1A and B experience of FY 64-65 shows the lowest rate of all models at 1.1/100,000 flying hours. In its seven survivable fire accidents, the fuel tanks neither ruptured nor punctured. They remained intact and no fuel was spilled.

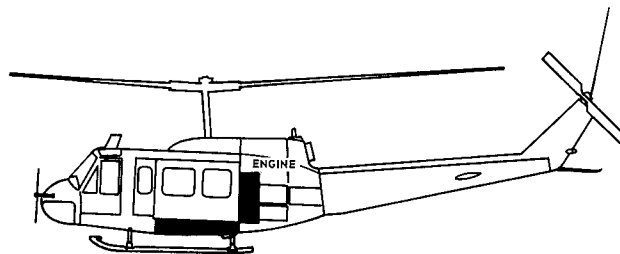
FIGURE 5

UH-1D Model Added Cells Aft of Cockpit

The record of the UH-1D which has a larger fuel capacity than the A and B, shows that the cells remained intact in four of its five survivable fire accidents. In the one accident,¹⁰ leaking fuel from the ruptured tank did not get involved in the fire. The engine fire that erupted was put out with portable fire extinguishers before the fuel from the ruptured tank was reached. The UH-1D rate indicated in Table 2 of 4.9/100,000 flying hours is attributed to engine malfunction, the electrical system, and transmission oil system. The fuel system was indicted for the cause of one because of the improper design of its vent system.

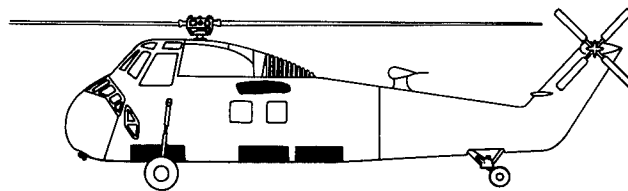
FIGURE 6

CH-34 With Three Fuel Cells in the Belly of the Helicopter

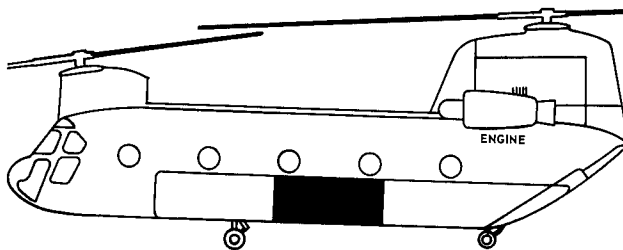
FIGURE 7

Similar design practices are found in the UH-19, CH-21, and CH-47. In the Chinook (CH-47), however, this combination of features is somewhat better (see Figure 7). The fuel cells, though located below floor level, can be penetrated by the rear landing gear, but are some distance from the engines which are mounted on each side of the aft rotor pylon.

CH-47 Fuel Cells Remote From Engine Area

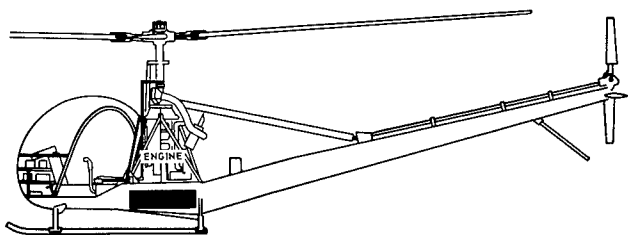
FIGURE 8

OH-23 Single Bladder-Type Fuel Cell

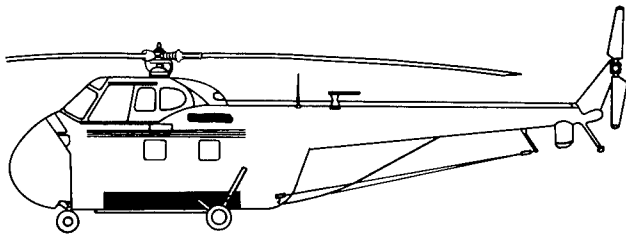
FIGURE 9

UH-19 Fuel Cell Location in Relation to Landing Gear and Engine Area

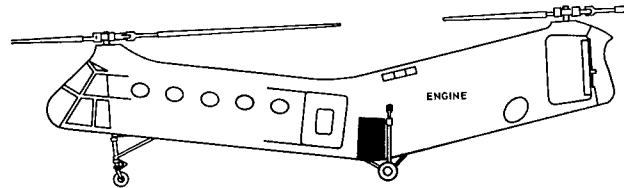
FIGURE 10

CH-21 in Relation to Landing Gear Fuel Cell Location and Engine Area
